Manhole Inspection Summary

Manhole # S47E2_008MH

Insp Date: **1/18/08 10:42 AM**

Location Address: **4112 Plum-Olmstead**

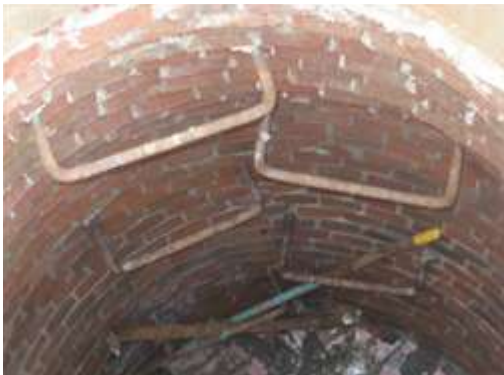
Steps

Count: **5** Missing: **0** ☐ Corroded

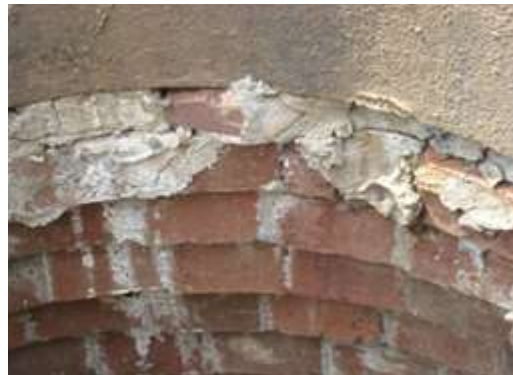
Defect 2

Infiltration: ☐ None ☐ Joint ☒ Cracks ☒ Mortar ☐ Roots ☐ Wall

Mortar infiltration

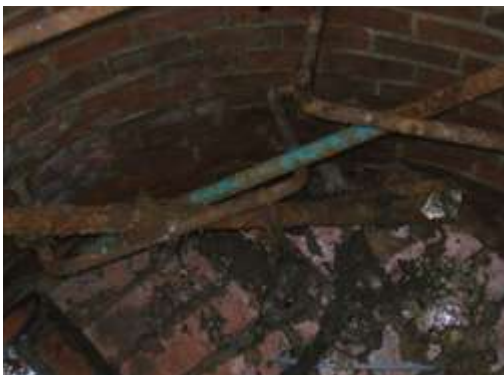
Defect 1

Poles in steps

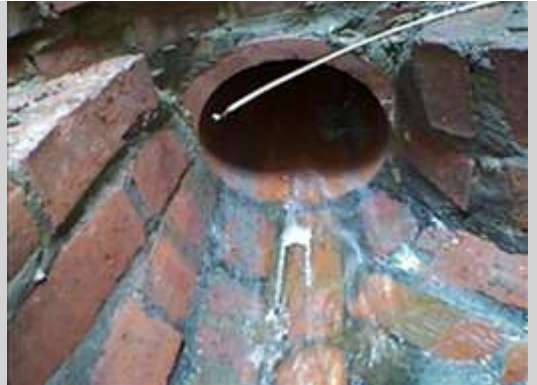
12 O'Clock Outflow

Pipe Height: **8.4** (in.) Rod and Bar (Angled)
Pipe Material: **Clay** ☐ Pipe Lined
Invert Depth: **10.11** (ft.) Flow Characteristics: **Fast**
Deposits: ☒ None ☐ Mud ☐ Sludge ☐ Debris ☐ Grease
Silt Depth: (in.) Deposits Extent:
Infiltration: **None** Pipe Seal Cond: **Sound**

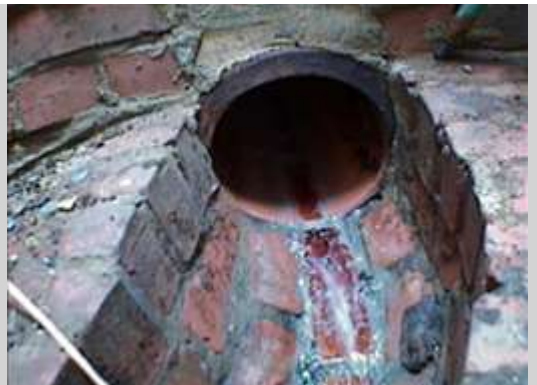
3 O'Clock Inflow

Pipe Height: **8.4** (in.) Rod and Bar (Angled)
Pipe Material: **Clay** ☐ Pipe Lined
Invert Depth: **9.52** (ft.) Flow Characteristics: **Slow**
Deposits: ☒ None ☐ Mud ☐ Sludge ☐ Debris ☐ Grease
Silt Depth: (in.) Deposits Extent:
Infiltration: **None** Pipe Seal Cond: **Sound**

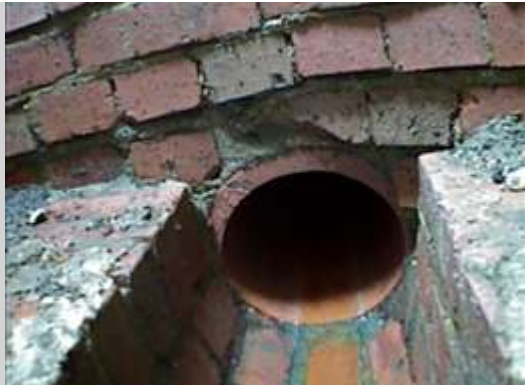
6 O'Clock Inflow

Pipe Height: **8.4** (in.) Rod and Bar (Angled)

Infiltration: **None** Pipe Seal Cond: **Sound**

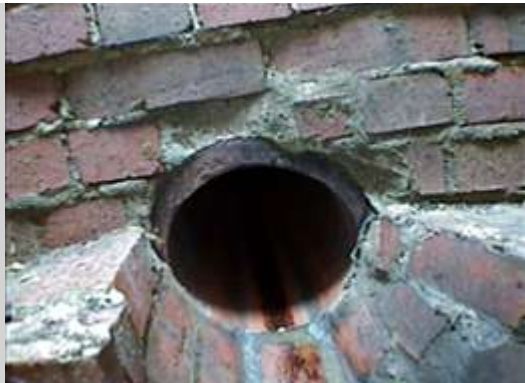
9 O'Clock Inflow

Pipe Height: **8.4** (in.) Rod and Bar (Angled)

Infiltration: **None** Pipe Seal Cond: **Sound**
